HIGH-LEVEL TACTILE INSPECTIONS

SAMPLING PHASE 1
REPORT
Kelso Abbey
PIC151

Title:	High-Level Tactile Sample Inspection Project Phase 1 Report PIC151 Kelso Abbey
Authors:	[REDACTED]
Document created:	August 2021
Reviewed by:	[REDACTED]
Date Reviewed:	07/09/2021
Approved by:	[REDACTED]
Date of Approval:	09/09/2021
Version Number:	V0100

PIC ID # ↓	PIC151	Site name	Kelso Abbey		
Inspection start	09/08/2021	Inspection end	11/08/2021	Submission	07/09/2021
Lead HBFA	[REDACTED]				
Sample Inspectors	[REDACTED]

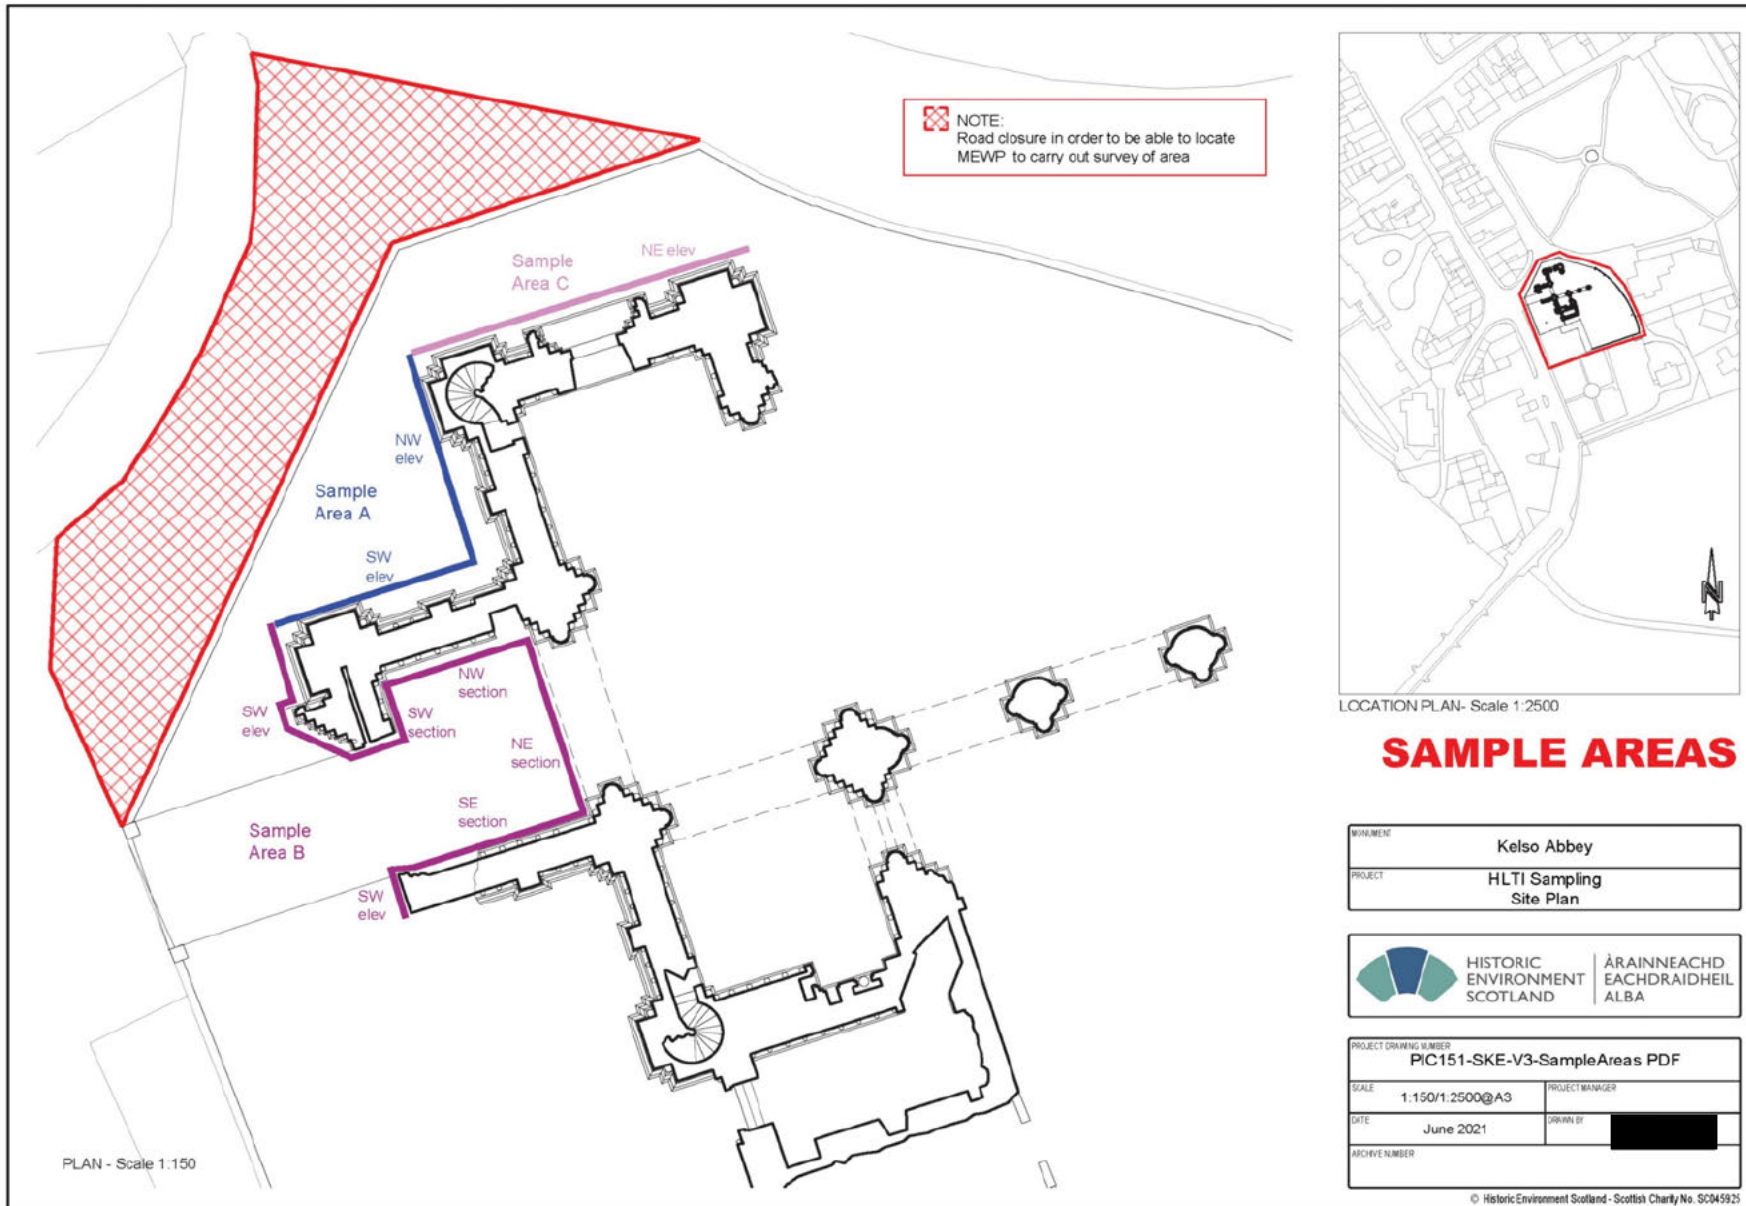
The High level tactile inspections covered three sample areas. These were the West elevation and entrance door; the North elevation and entrance door; and the North West and South West corner inbetween the North and West doorways. All areas were agreed in advance by the T1 team and the Region) and completed using a MEWP.

Area:	Colour:	Sample Area Name:
A	[Blue]	SW & NW External Elevations
B	[Purple]	Galilee Internal Elevations & West Door External Elev.
C	[Pink]	NW External Elevations North Door
