HIGH-LEVEL TACTILE **INSPECTIONS**

SAMPLING PHASE 1 REPORT Tantallon Castle PIC164

Title:	High-Level Tactile Sample Inspection Project Phase 1 Report PIC164 Tantallon Castle
Authors:	
Document created:	August 2021
Reviewed by:	
Date reviewed:	17/09/2021
Approved by:	
Date of Approval:	17/09/2021
Version Number:	V0100

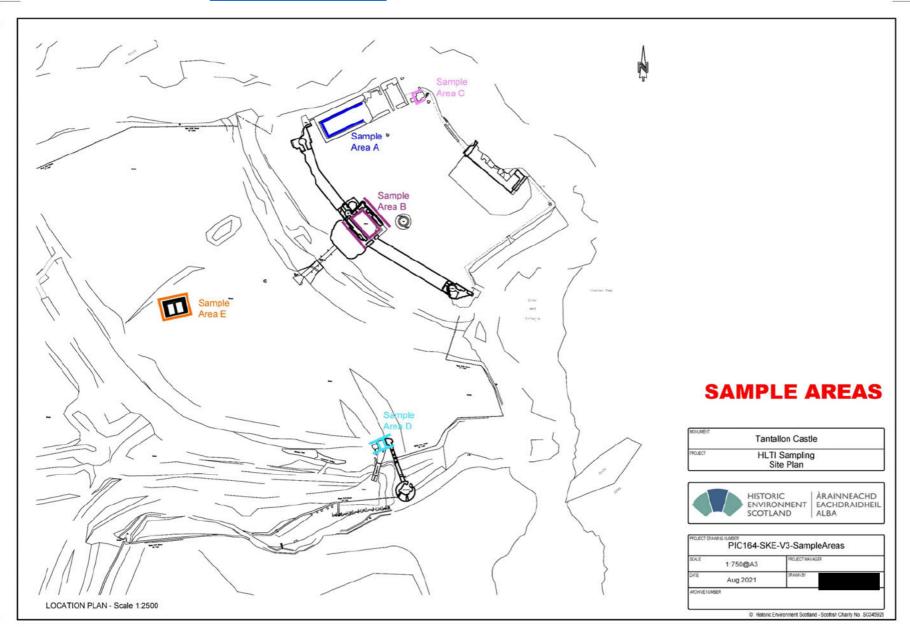
Click on link to open drawing in PDF viewer: PIC164-SKE-V3-SampleAreas.pdf

Tactile inspections of five sample areas (Kitchen Range/Leigh Hall (A), Gatehouse and Foretower (B), remaining Stack of masonry at the North end of the Kitchen Range (C), the Outer Gate (D) and the Doocot (E) were completed from an alloy tower or using rope access/steeple jack teams (observed with GoPro Cameras).

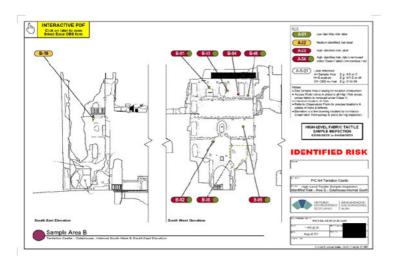
PIC164-HLR-SI-B-IntS.pdf

Loose fragments of sufficient height and/or size to cause severe injury or death to people below were found inside the gatehouse. The risk of injury or death is heightened as all visitors to the castle have to pass through the restricted space below to enter the castle. Of particular risk are the arch voussoirs of the southern upper window where two sizeable fragments detached during inspection. Further voussoirs are cracked and an associated structural crack runs through the window to the wall head. Sizeable areas of surface delamination were observed on the stepped gable skews of the doocot and the harling was found to be boss in many areas on this structure. No high risk areas remain outstanding inside the Kitchen Range/Leigh Hall or the stack at the North end of the Kitchen range nor on the outer gate adjacent to the visitor path.
