High Level Masonry Project  
Tactile safety inspection of high-level fabric

REPORT  
Castle Sween  
PIC060

December 2022

HISTORIC  
ENVIRONMENT  
SCOTLAND

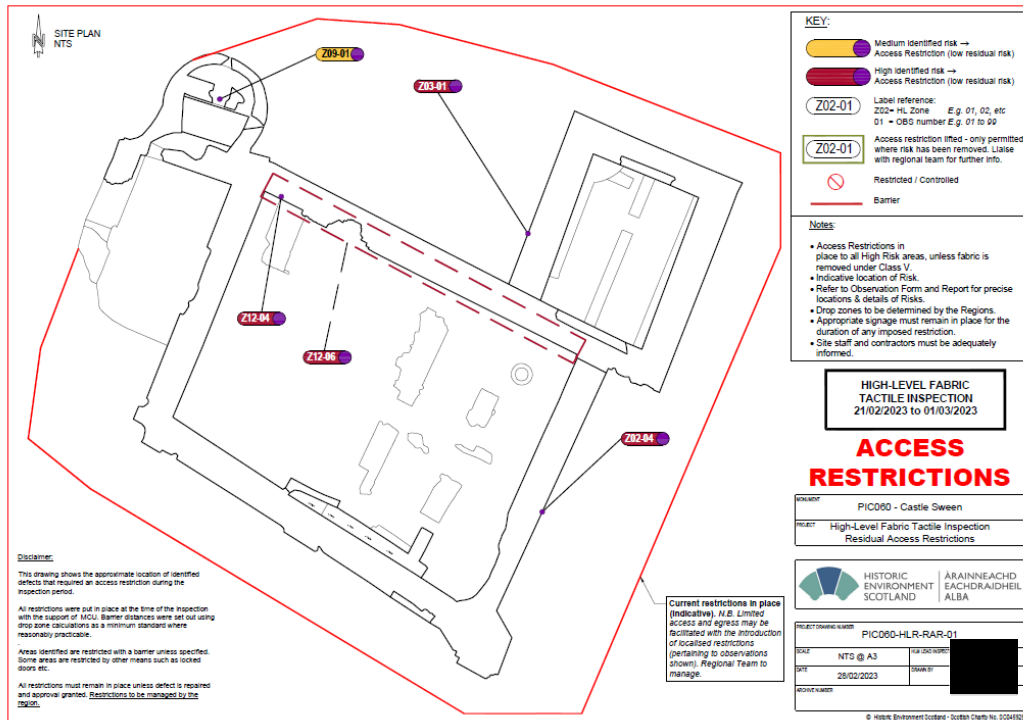
[PIC060-HLR-RAR-01](#)

- Generally site in good condition
- Vegetation Growth on wall heads requires to be removed
- Repairs carried out where required at accessible points
- Three access restrictions recommended if site is to open ( Risk Sketch on TEAMS)
- 
- 
-
