# Tactile safety inspection of high-level fabric

REPORT  
Craigmillar Castle  
PIC 134

Title:	Tactile safety inspection of high-level fabric. Report PIC134 Craigmillar Castle
Authors:	
Document created:	April 2021
Approved by:	
Date of Approval:	
Version Number:	V0200

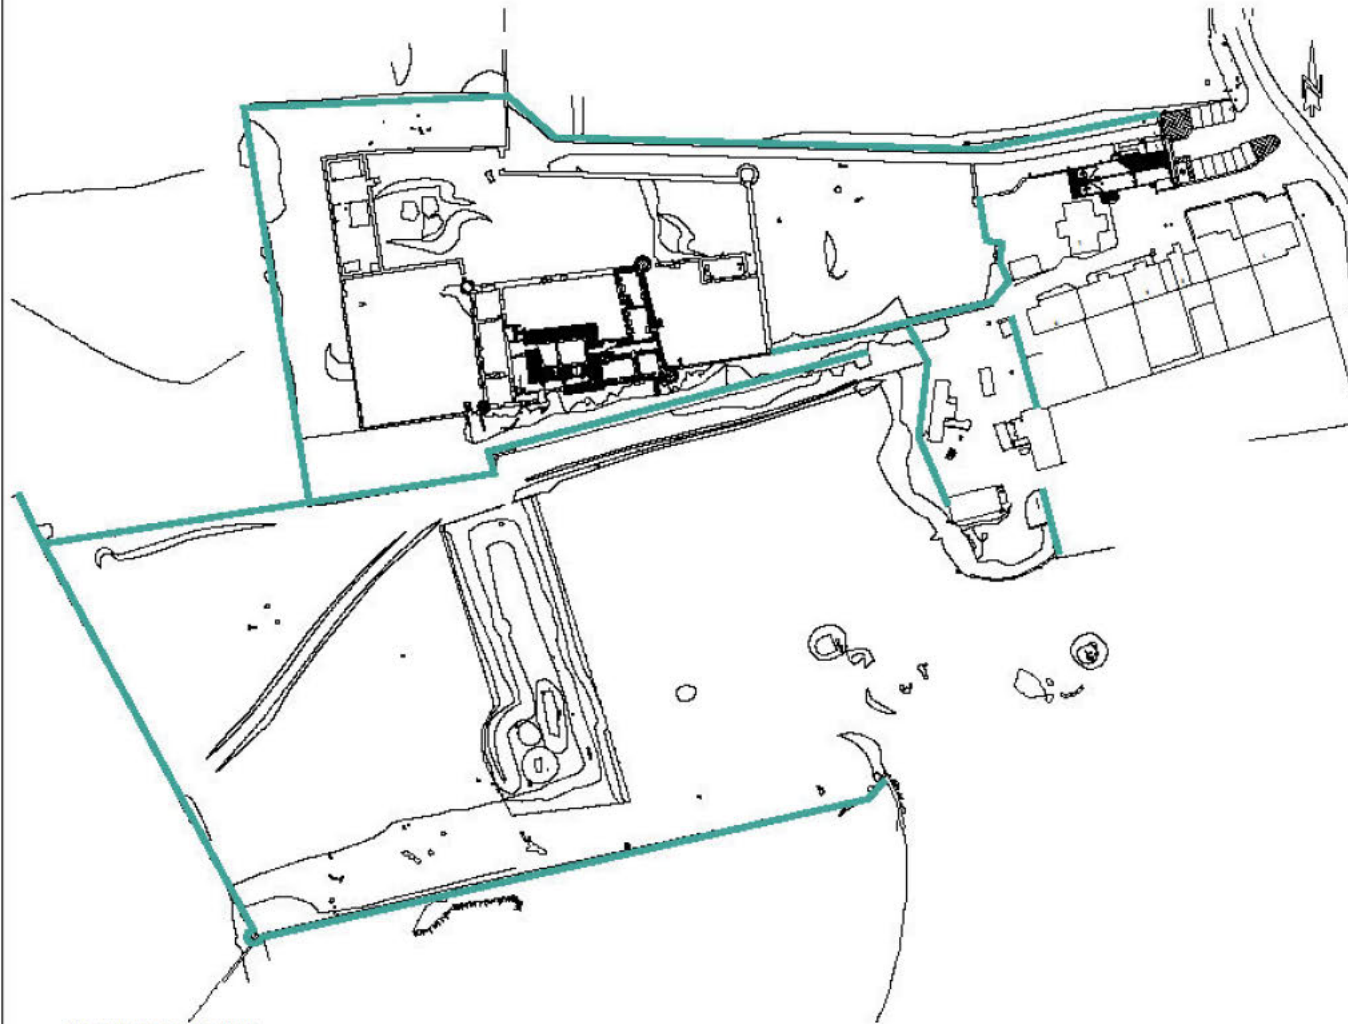
SITE PLAN - Scale 1:1000

<b>KEY:</b>	
	ZONE 11 - 1 day - Ground

- PIC134-HLZ-01 C
- PIC134-HLZ-02 C
- PIC134-HLZ-03 C
- PIC134-HLZ-04 C
