Tactile safety inspection of high-level fabric

REPORT St Andrews Cathedral PIC035

High-Level Tactile Inspection: Report - Introduction

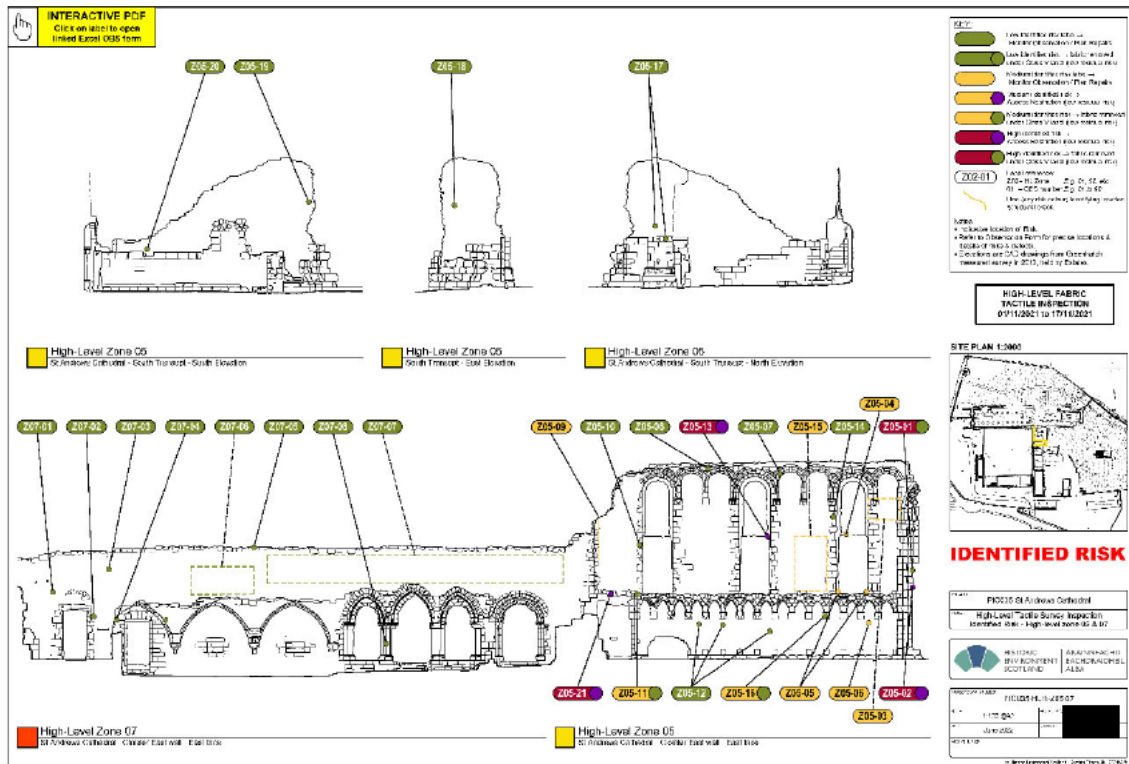
PIC035-HLR-Z05 07

Click on link below image to open Interactive PDF in PDF viewer. In PDF viewer, the drawing is an interactive PDF, click on the labels to open the relevant OBS form for further information.
